## "Full" Reserve Study

### **White Pass Village Inn White Pass, WA**

**Report #: 36105-0**  
**For Period Beginning: July 1, 2019**  
**Expires: June 30, 2020**

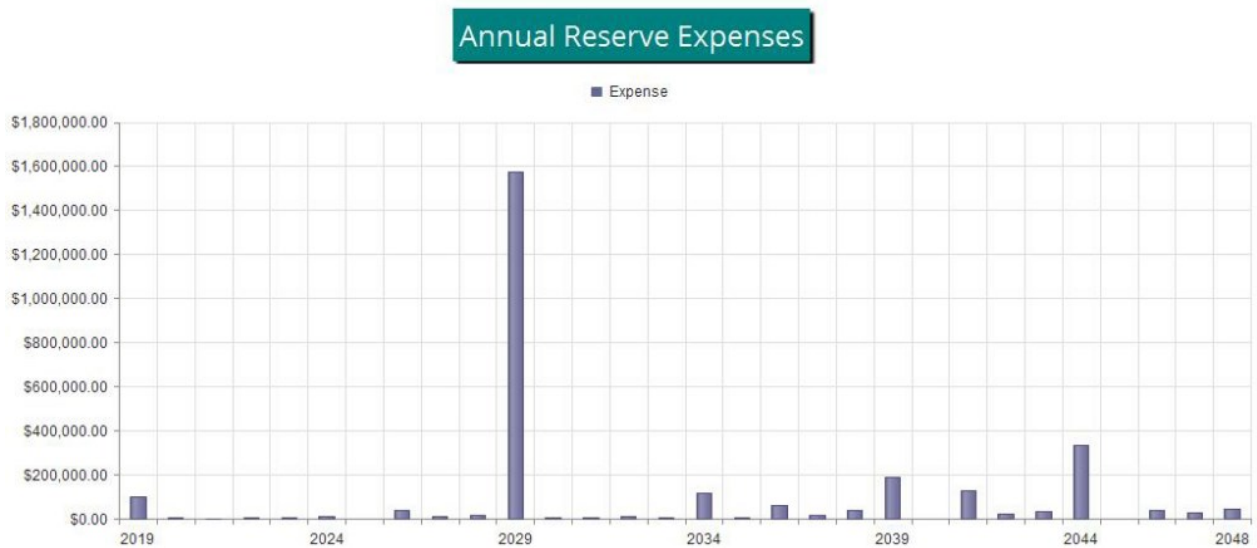
Figure 1

The figure below summarizes the projected future expenses at your association as defined by your Reserve Component List. A summary of these expenses are shown in the 30-yr Summary Table, while details of the projects that make up these expenses are shown in the Cash Flow Detail Table.

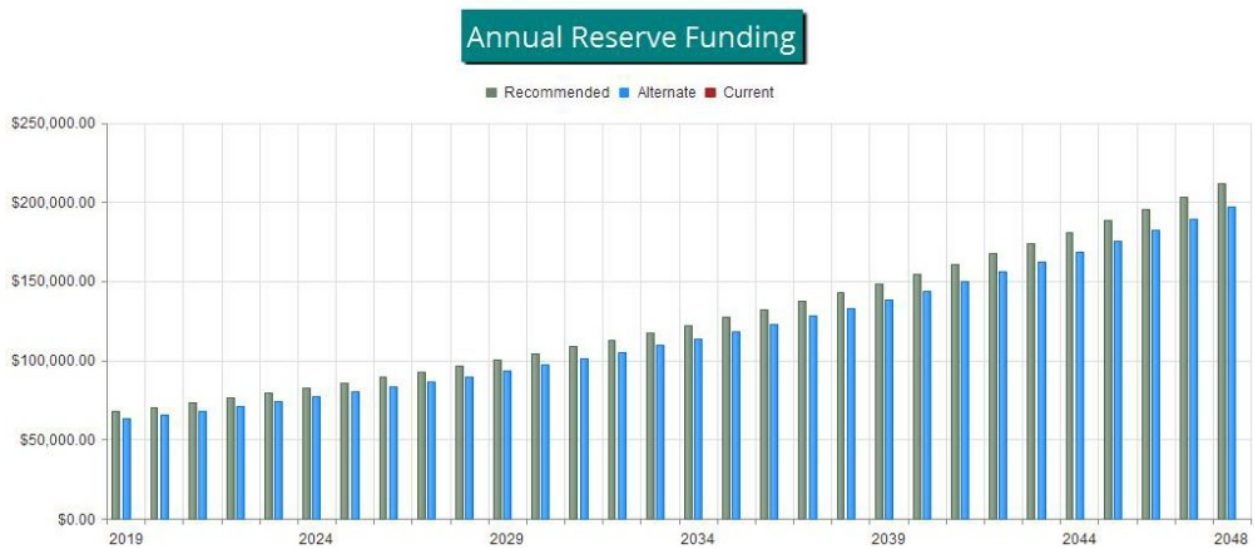
Figure 2

Based on your current Percent Funded and your near-term and long-term Reserve needs, we are recommending budgeted contributions of \$5,657 per month this Fiscal Year. The overall 30-yr plan, in perspective, is shown below. This same information is shown numerically in both the 30-yr Summary Table and the Cash Flow Detail Table.

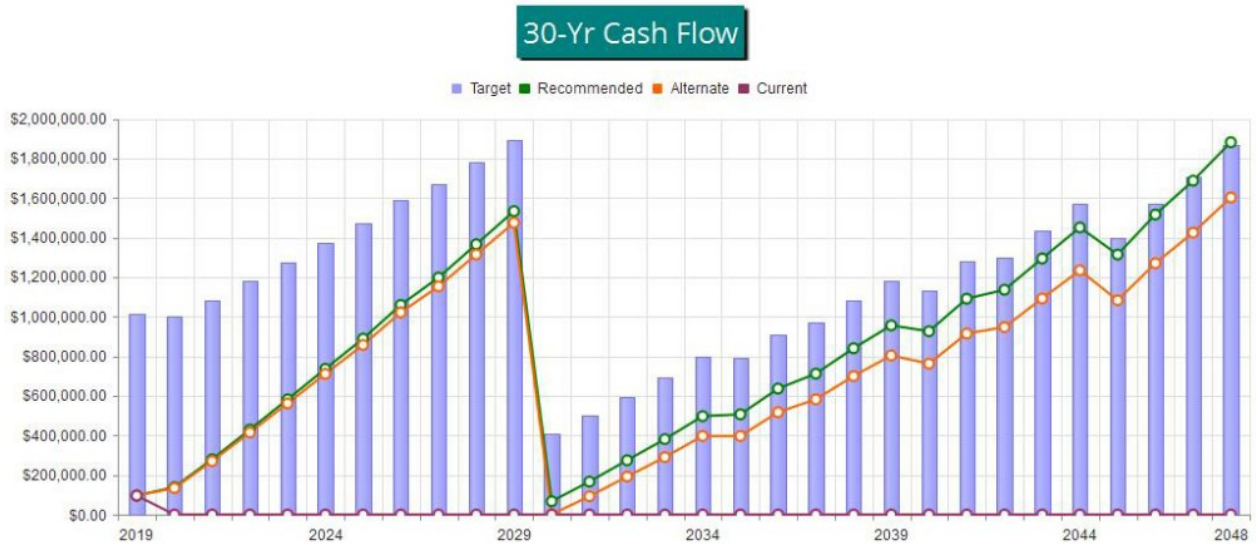
Figure 3

The following chart shows your Reserve balance under our recommended Full Funding Plan, an alternate Baseline Funding Plan, and at your current budgeted contribution rate (assumes future increases), compared to your always-changing Fully Funded Balance target.

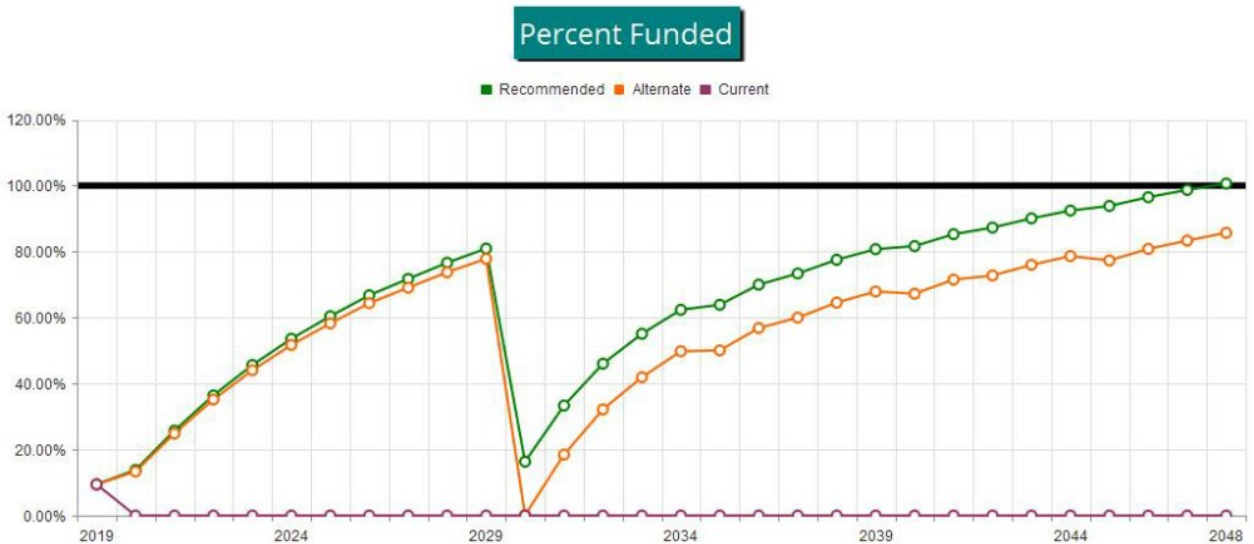
Figure 4

This figure shows the same information plotted on a Percent Funded scale. It is clear here to see how your Reserve Fund strength approaches the 100% Funded level under our recommended multi-yr Funding Plan.

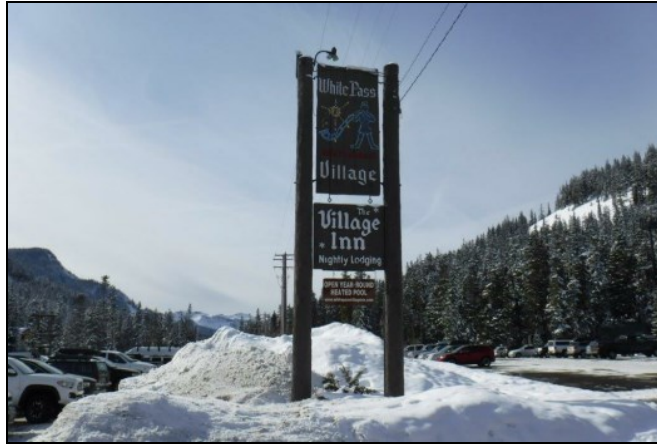
Useful Life:  
25 years

Remaining Life:  
10 years

Best Case: \$ 2,500

Worst Case: \$ 3,500

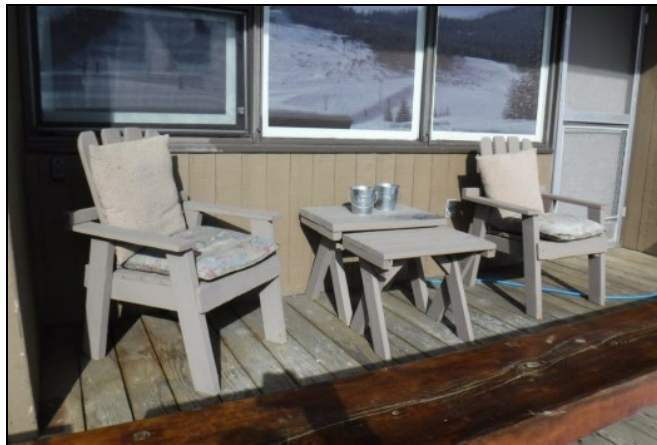
Useful Life:  
20 years

Remaining Life:  
10 years

Best Case: \$ 6,000

Worst Case: \$ 9,000

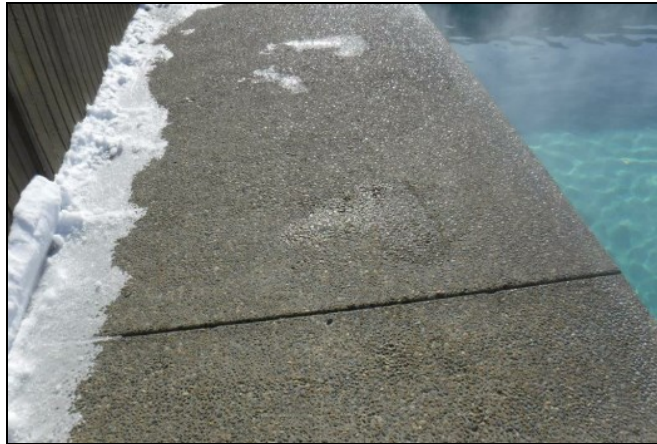
Useful Life:  
50 years

Remaining Life:  
17 years

Best Case: \$ 13,100

Worst Case: \$ 17,400

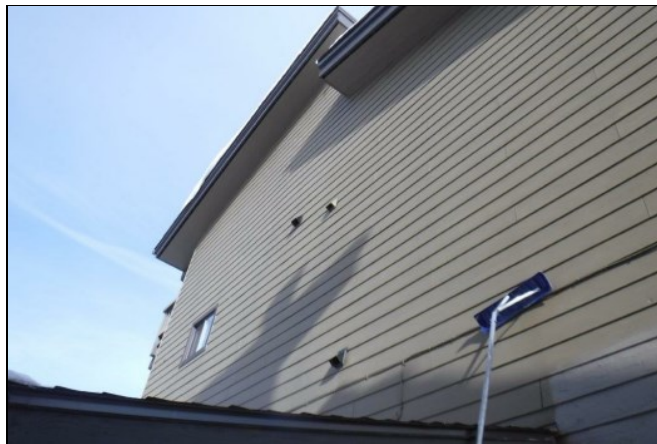
Useful Life:  
50 years

Remaining Life:  
40 years

Best Case: \$ 146,600

Worst Case: \$ 224,800

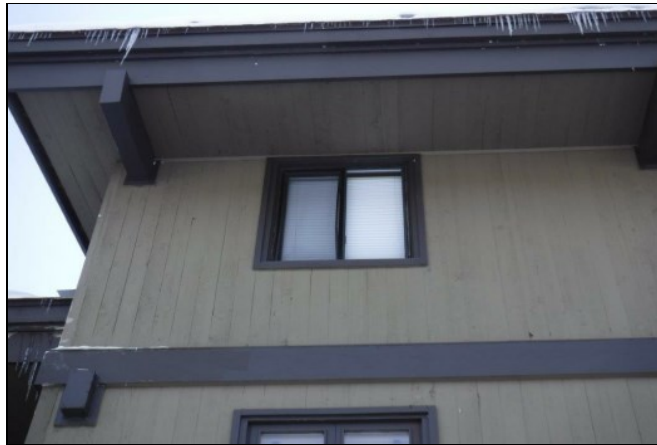
Useful Life:  
50 years

Remaining Life:  
10 years

Best Case: \$ 524,600

Worst Case: \$ 804,400

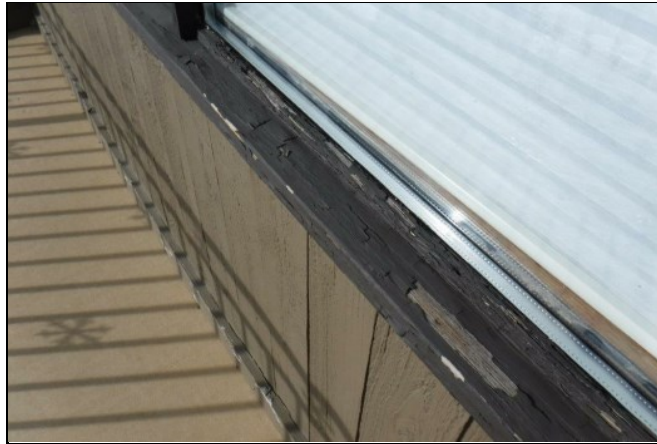
Useful Life:  
10 years

Remaining Life:  
0 years

Best Case: \$ 83,300

Worst Case: \$ 119,900

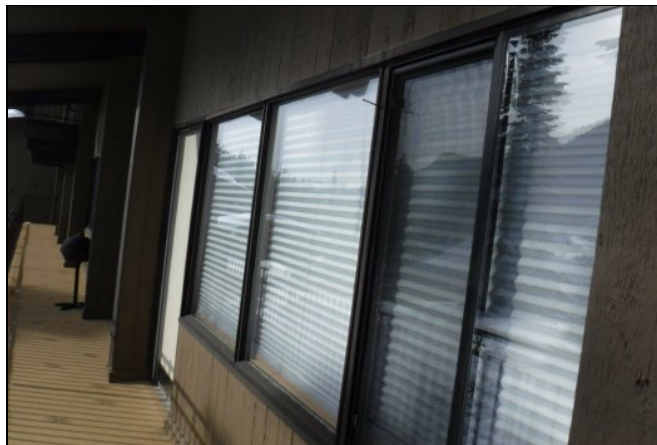
Useful Life:  
50 years

Remaining Life:  
10 years

Best Case: \$ 123,000

Worst Case: \$ 184,500

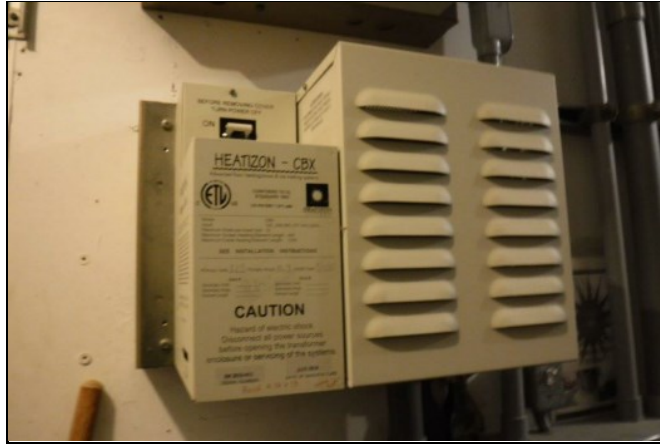
**Comp #: 908 Snow Melt System - Repair/Replace**

There is no predictable basis to expect expenses affecting reserves at this basic system, therefore repair as needed utilizing general maintenance operating funds. Update future reserve studies should need for complete replacement arise.

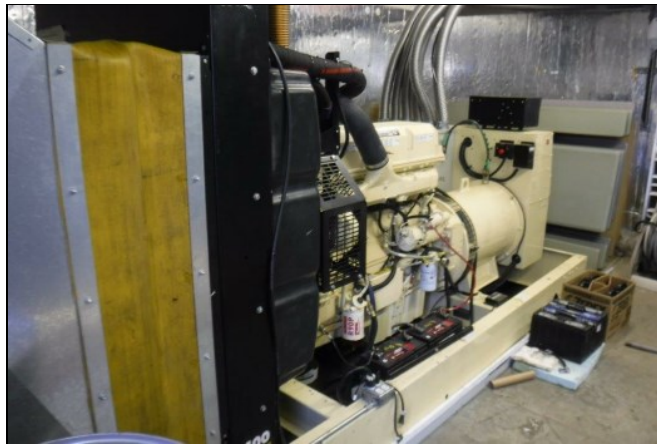
**Comp #: 909 Generator - Repair/Replace**

Life span of emergency generators varies greatly, but for financial planning purposes, we suggest planning for eventual replacement. Timing of replacement is difficult to predict and can be brought about when replacement parts are hard to find or no longer available. As the generator ages, wait time for parts can significantly increase and costs of renting an emergency generator during that time can be very costly.

Many generator vendors recommend maintenance twice a year. Typically, this includes replacing the coolant and the hoses every 2 to 3 years and replacement of batteries. These costs are below the reserve fund threshold and should be considered operational expenses.

Generator system is composed of the fuel pump assembly, the engine, and the head end controls, switch. Costs below include installing an entire new system. Replacement options may include installing a remanufactured engine or replacing major components over time. Discuss this item with your vendor to better determine a replacement plan.

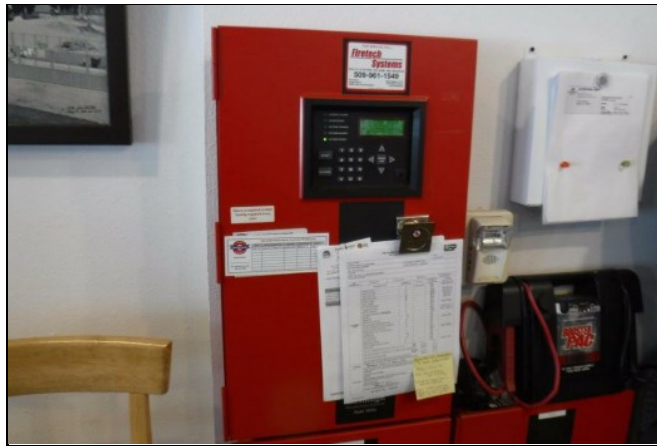
**Comp #: 965 Fire Alarm Panel - Repair/Replace**

Our experience suggests that an approximate useful life for the panel for budget planning purposes is in the 20 year range. Discuss this component with your fire panel vendor or consultant to better determine the timing of panel repair or replacement needs, and to assess the overall system in relation to the current codes, and parts & technician availability to determine if upgrades or replacement will be required.

Scope of work at time of repairs can vary greatly based on the amount of work needed to bring the existing fire system to the level required by the fire/building codes in place at that time. Evaluating the entire fire prevention system is beyond the scope of a reserve study. Replace panel as needed, and perform additional upgrade as required by code. Costs below are for repair and/or replacement of only the panel.

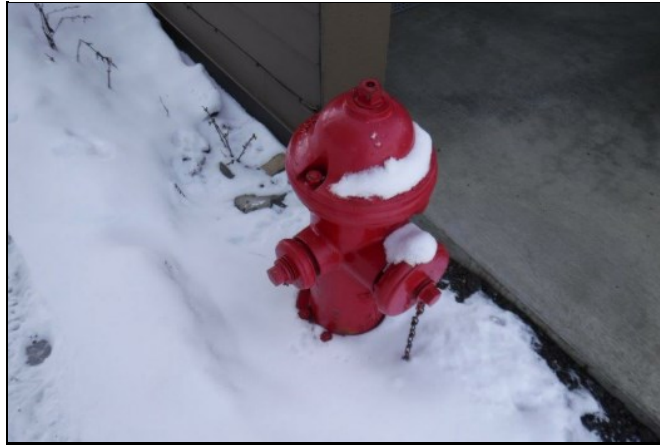
**Comp #: 966 Fire Hydrants - Repair/Replace**

Comments: Our source reported that two of the three fire hydrants were in need of repair, with one possibly requiring replacement.

Typically, these fire hydrants are a long lived item of which replacement is difficult to predict. The most common repair requirement is valve replacement due to frozen valves. While there is no predictable basis to expect reoccurring replacement of hydrants, we have included a rotating allowance for periodic repairs based on the association's history of repairs.

As routine maintenance, test hydrants and exercise valves as directed by current fire code. Consult with local fire department and/or fire systems vendor for maintenance recommendations.

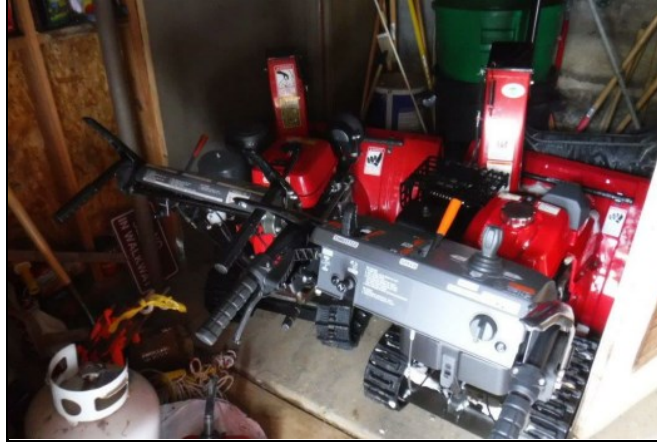
**Comp #: 970 Snowblowers - Replace**

Comments: Association records indicate that snowblowers were replaced in 1998 and 2012. No problems were reported at the time of our site visit. Our source reported that snow blowers receive heavy use during winter months.
